Cal 25 Mast Beam Repair

Cal 25 Class Association

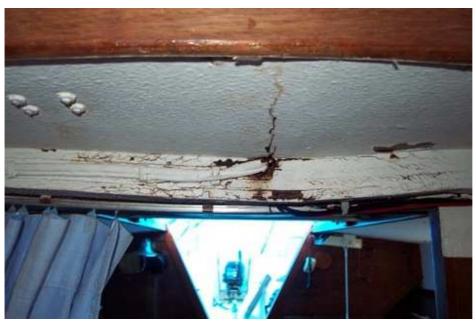
A good example of a sagging beam, a common occurrence for many CAL 25's, but one that is fixable.
